Prof. Dr. Holger Schlingloff

Institut für Informatik der Humboldt Universität

MARS POLAR LANDER

searching for water on mars

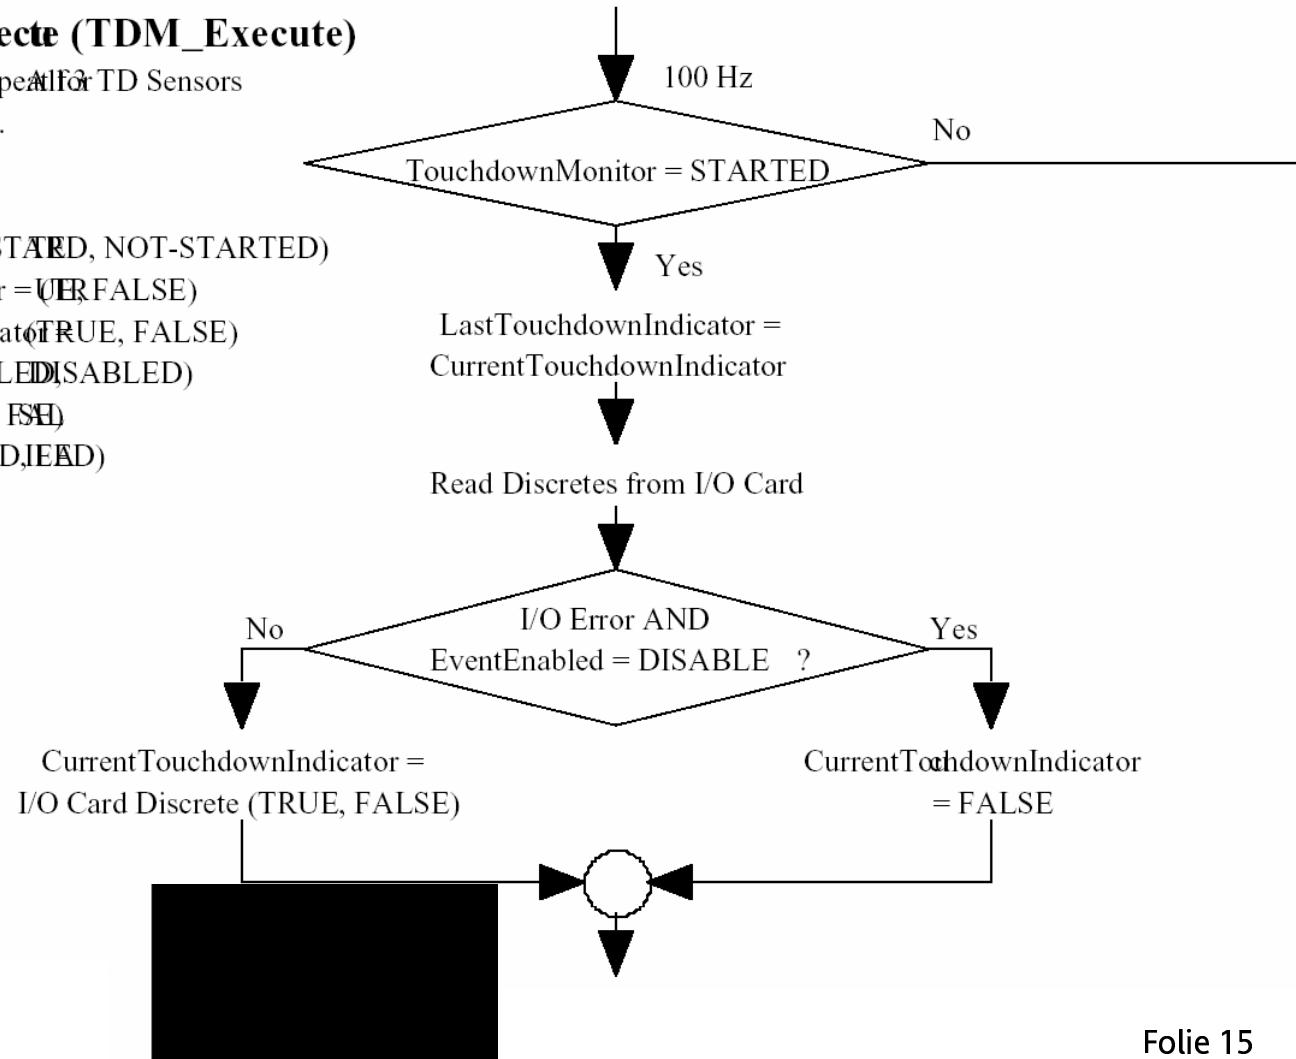
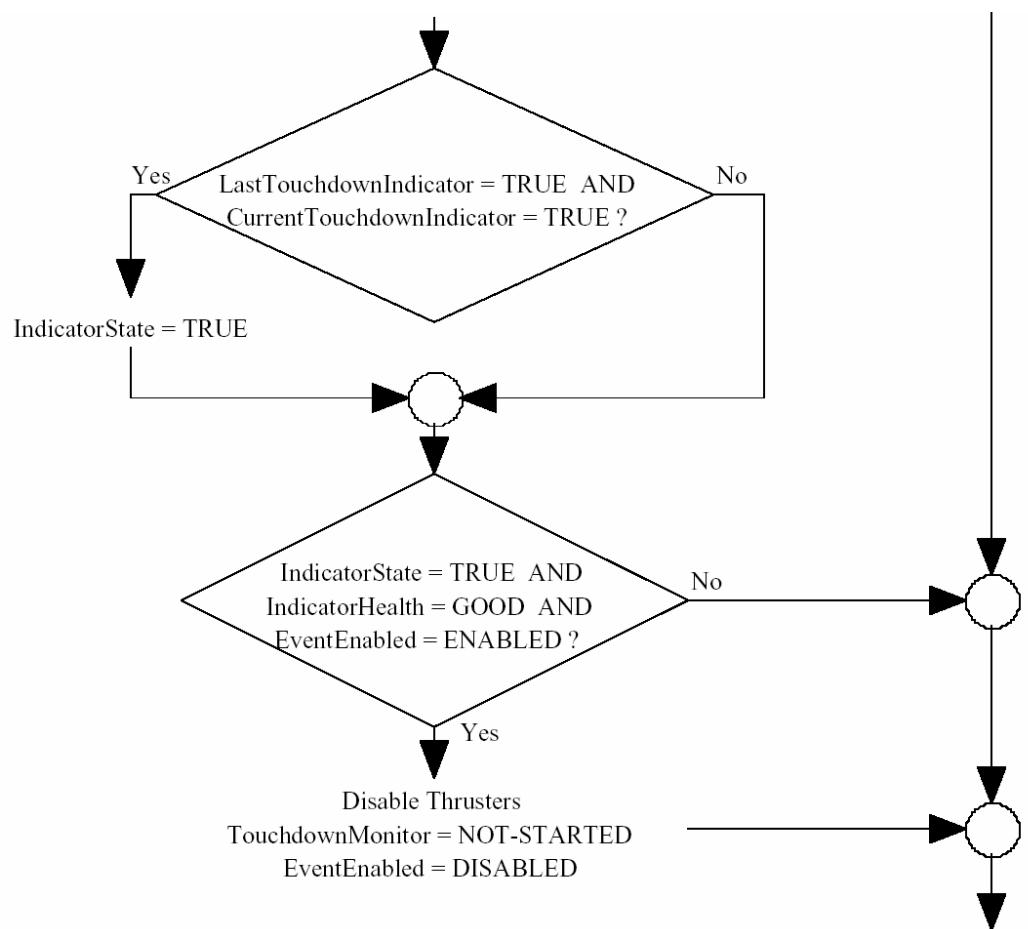
Touchdown Monitor Execute (TDM_Execute)

Chart Shows Single TD Sensor; repeat for TD Sensors
TDM_Execute is called at 100 Hz.

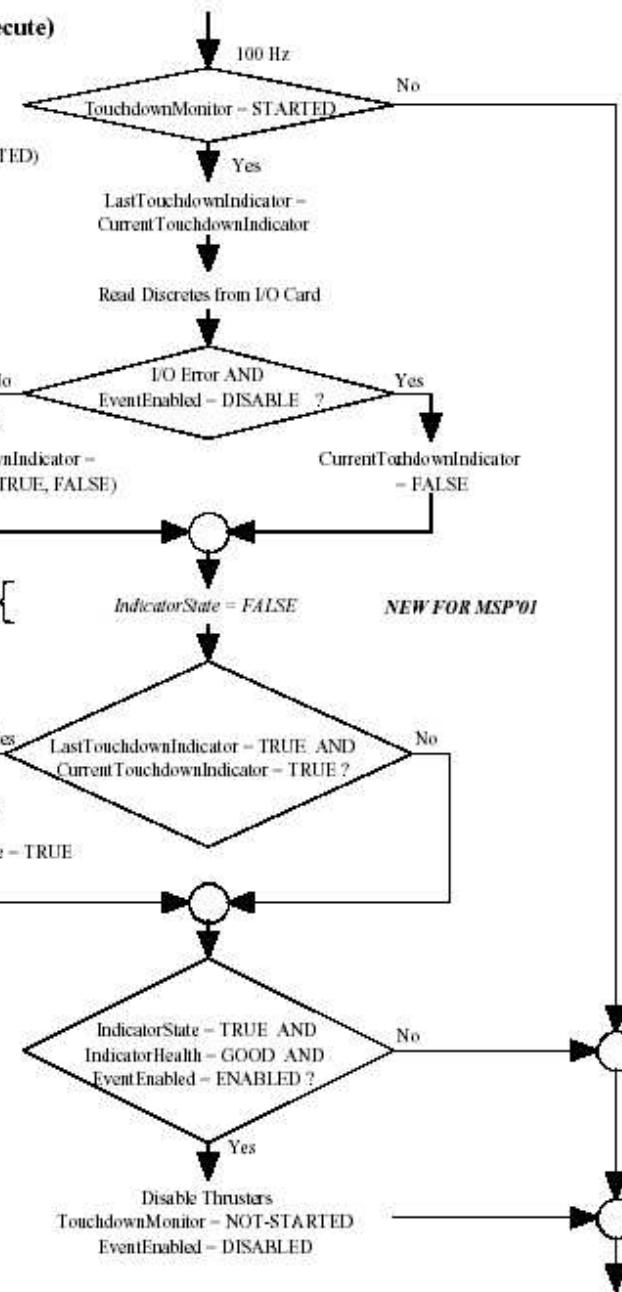
Figure 7-8. Touchdown Monitor Functional Flow Diagram

The software — intended to ignore touchdown indications prior to the enabling of the touchdown sensing logic — was not properly implemented, and the spurious touchdown indication was retained. The touchdown sensing logic is enabled at 40 meters altitude, and the software would have issued a descent engine thrust termination at this time in response to a (spurious) touchdown indication.

-
- zunächst ein reines Programmier-Problem
 - falsche Variablenbelegung
 - Komplizierte Parallelausführung mit gemeinsamem Speicher
 - Ursache wurde quasi „zufällig“ beim Test der Software für die nächste Mission gefunden
 - Tester drückt Knopf um Sensorausfall in großer Höhe zu simulieren; wundert sich dass trotz Loslassen des Knopfes die Triebwerke abgeschaltet werden
 - Missachtung einer informell spezifizierten Anforderung
 - Probleme mit der Übertragung von Systemanforderungen in Softwareanforderungen

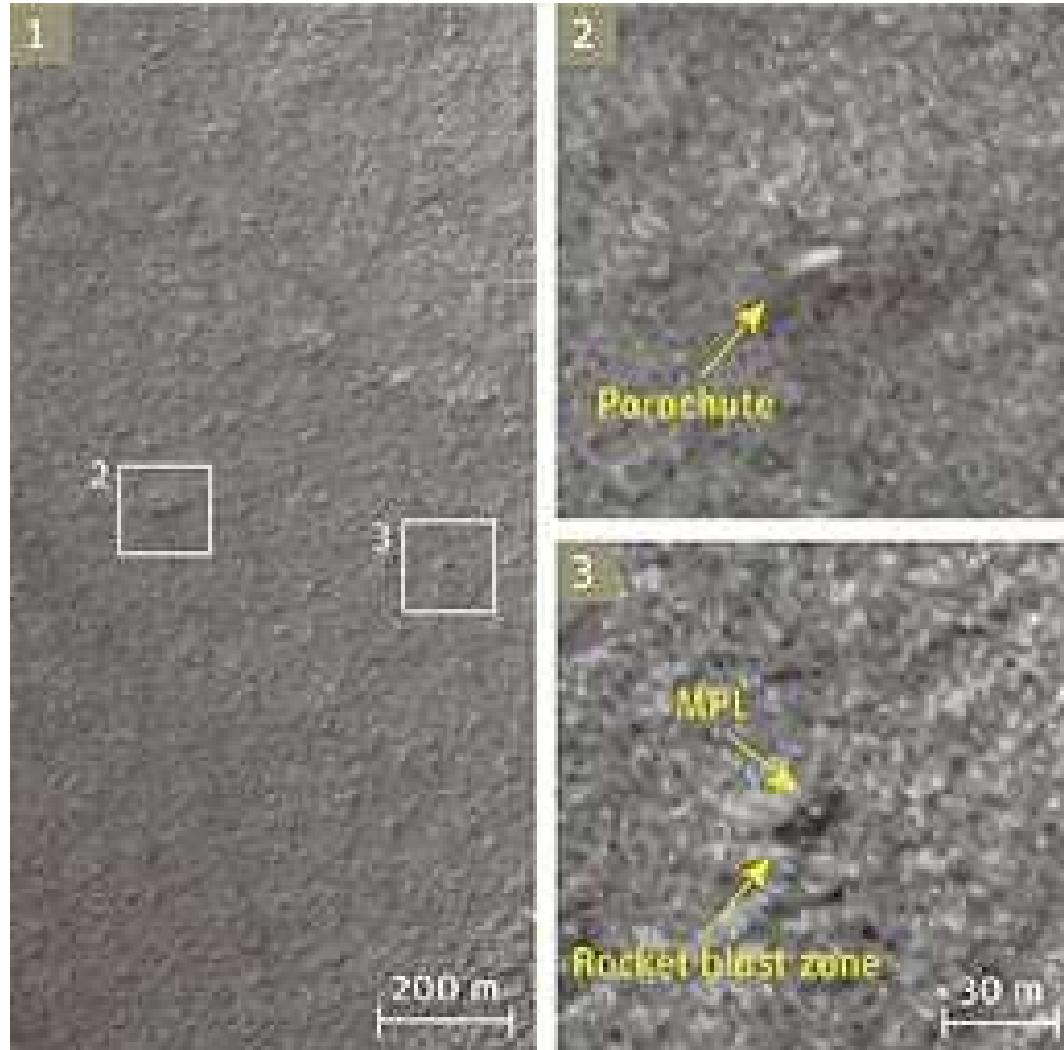
- Übrigens: Das Wrack wurde im Mai 2005 gesichtet und identifiziert!
(Identifikation einzelner Pixel in 150 Megapixel Bild)
- Weitere hochauflösende Aufnahmen (0.5m/Pixel) geplant um den Fall endgültig zu klären
