Prof. Dr. Holger Schlingloff

Institut für Informatik der Humboldt Universität

MARS POLAR LANDER

searching for water on mars

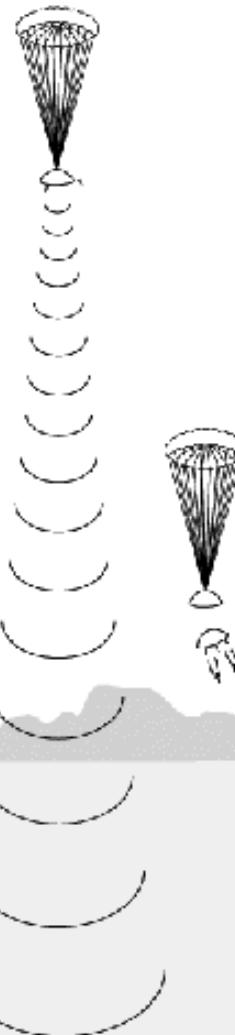
- Water hammer damage to propulsion system
- Propellant line rupture
- Loss of control authority (propulsion or thermal control failure)
- Loss of control (dynamic effects or center-of-mass offset)
- Loss of velocity control (Doppler Radar fails; Radar data lockout; algorithm singularity at zero velocity; depleted propellant)
- Premature shutdown of descent engines
- Excessive horizontal velocity causes lander to tip over at touchdown

Touchdown

- Surface conditions exceed design capabilities
- Engine plume interacts with surface
- Landing site not survivable (slope >10 degrees; lands on >30-cm rock, etc.)

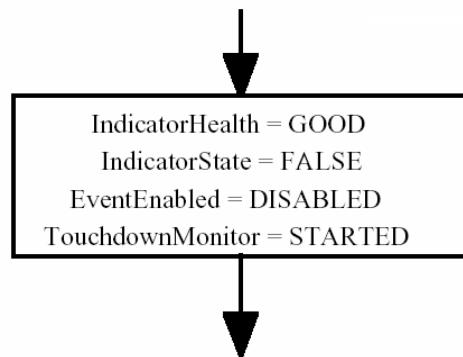
Touchdown Monitor Execute (TDM_Execute)

The software — intended to ignore touchdown indications prior to the enabling of the touchdown sensing logic — was not properly implemented, and the spurious touchdown indication was retained. The touchdown sensing logic is enabled at 40 meters altitude, and the software would have issued a descent engine thrust termination at this time in response to a (spurious) touchdown indication.

Chart Shows Single TD Sensor; repeat for TD Sensors
TDM_Execute is called at 100 Hz.

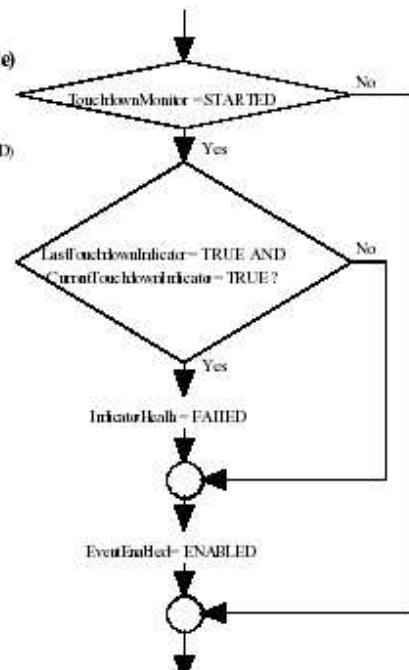
Touchdown Monitor Execute (TDM_Execute)

Chart Shows Single TD Sensor; repeat for TD Sensors
TDM_Execute is called at 100 Hz.

Upon enabling touchdown event generation, the lander flight software shall attempt to detect failed sensors by marking the sensor as bad when the sensor indicates “touchdown state” on two consecutive reads.
